## THESIS

The Effect Of Multiple Weld Repairs  
On The Fatigue Resistance Of  
Welded Aluminum Alloy 5083-0

John R. Panico

December 1979

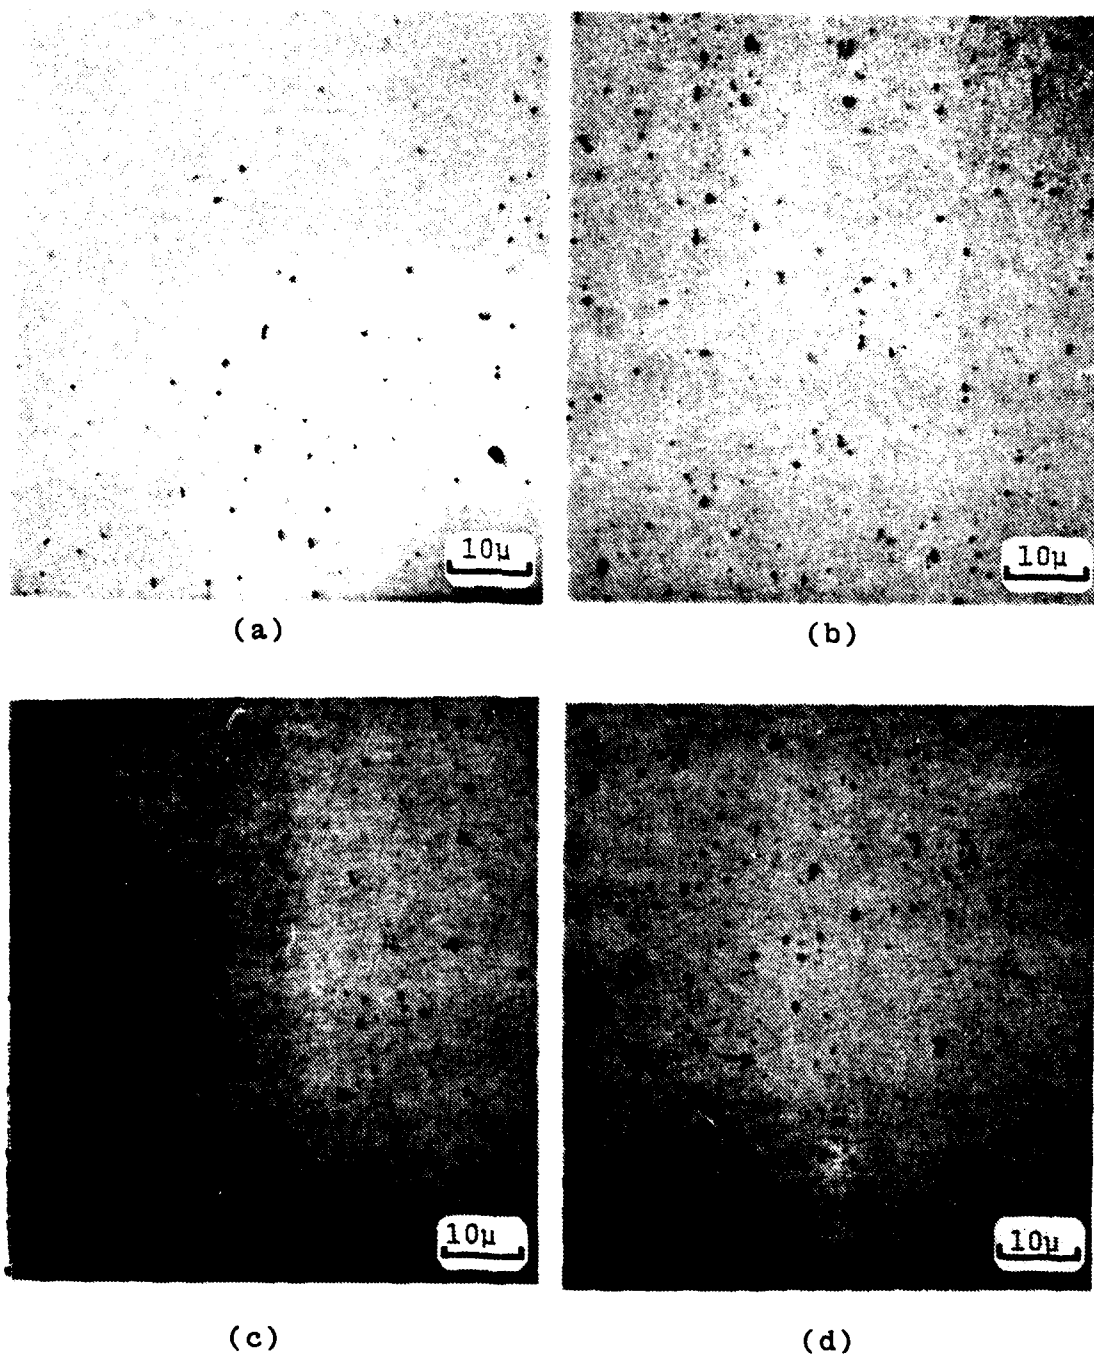
Lt. G.R. Speight's research in this area disclosed that the insoluble inclusions  $(\text{FeMn})_3\text{SiAl}_{12}$  and  $\text{Mg}_2\text{Si}$  grew and coarsened with increasing numbers of weld repairs [27]. Figures 9 and 10 illustrate this coarsening. Figure 9 shows micrographs of an as-polished specimen subjected to the original two-pass weld only. Figure 10 shows micrographs of an as-polished specimen subjected to sixteen repair simulations. This coarsening had little apparent effect on tensile strength, stress corrosion cracking susceptibility and hardness, although, as noted previously, there was a slight tendency toward degradation in these properties.

Figure 9. Photomicrographs taken of the "as-polished" specimen subjected to the original two-pass weld only. The locations represented are the interface (a), approximately 6 mm (b), 18 mm (c) and 27 mm (d) from the interface. (100X)

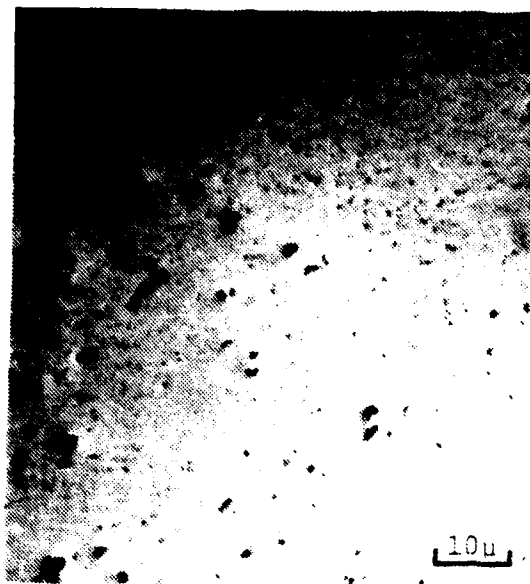
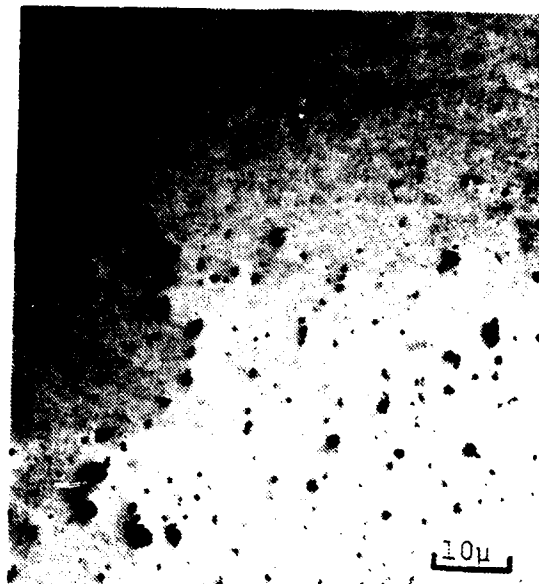
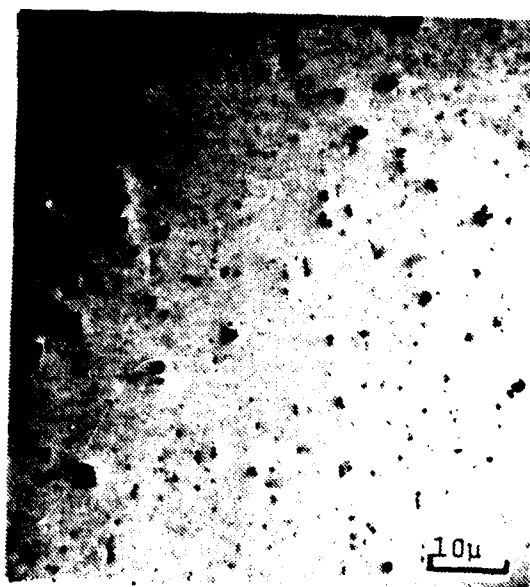
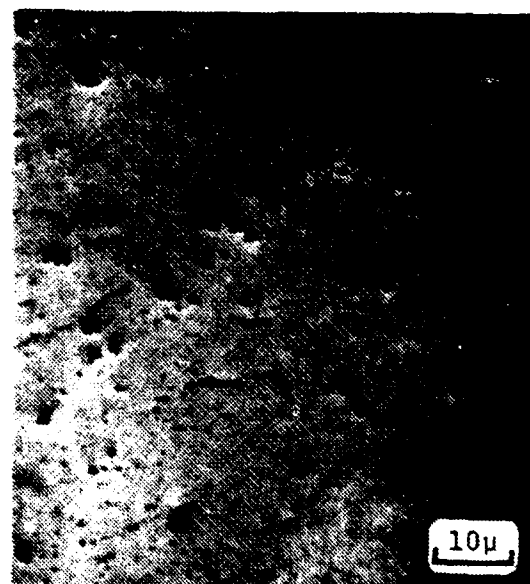
Figure 10. Photographs taken of the "as-polished" specimen subjected to 16 repair simulations. The locations represented are the interface (a), approximately 6 mm (b), 18 mm (c) and 27 mm (d) from the interface. (100X)

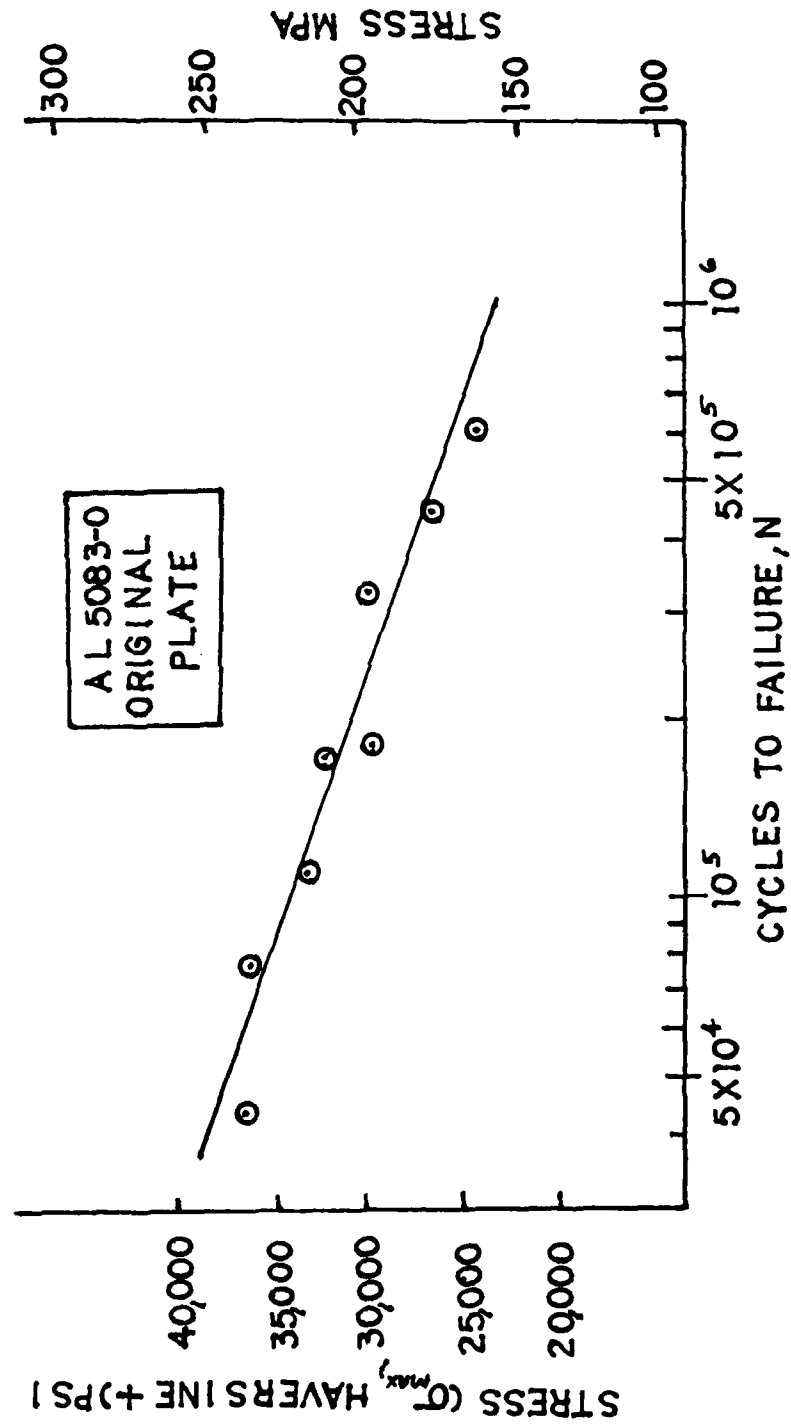
Figure 12. S-N Fatigue Diagram for AL 5083-0 original plate.  $\sigma_{MAX}$  on the haversine loading curve is plotted on the vertical axis while cycles to failure,  $N$ , is plotted on the horizontal axis.

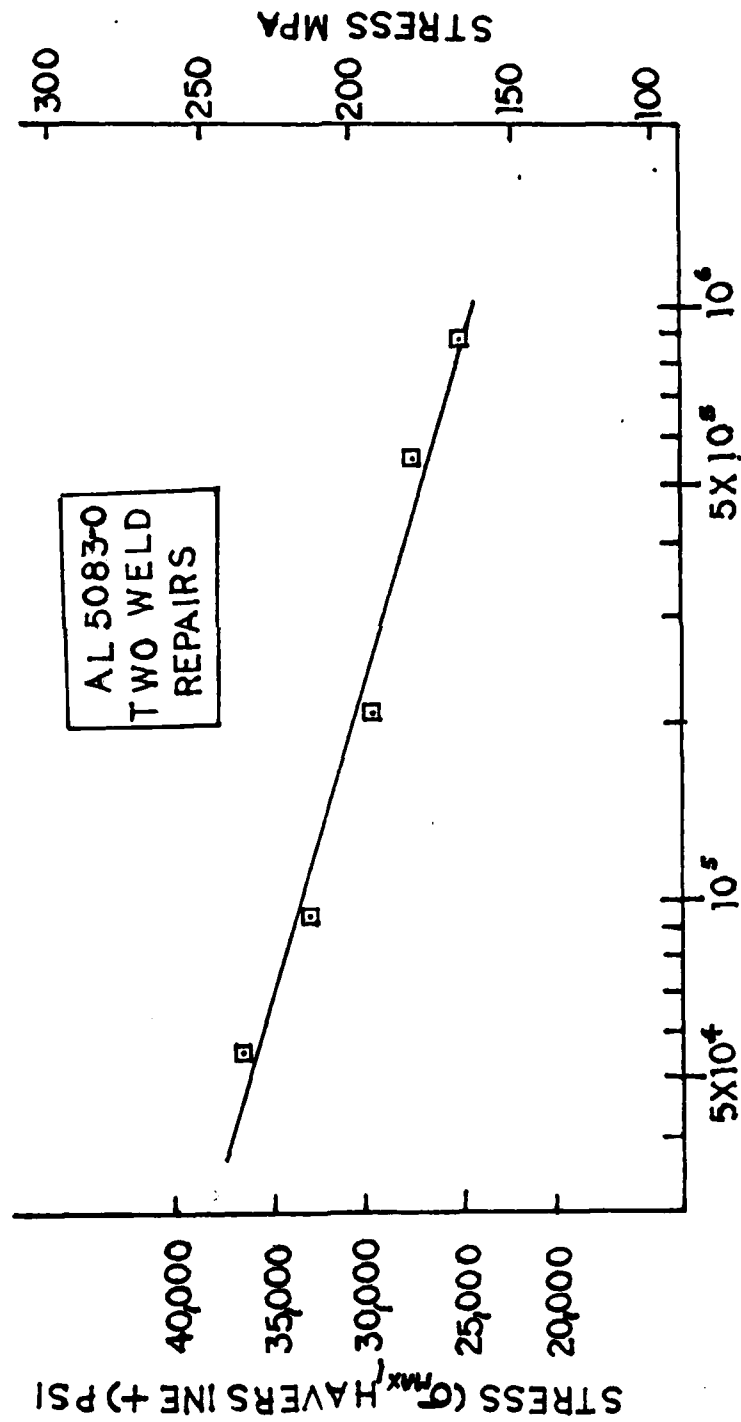
Figure 13. S-N Fatigue Diagram for AL 5083-0 which has been weld repaired twice.  $\sigma_{max}$  on the haversine loading curve is plotted on the vertical axis while cycles to failure, N, is plotted on the horizontal axis.

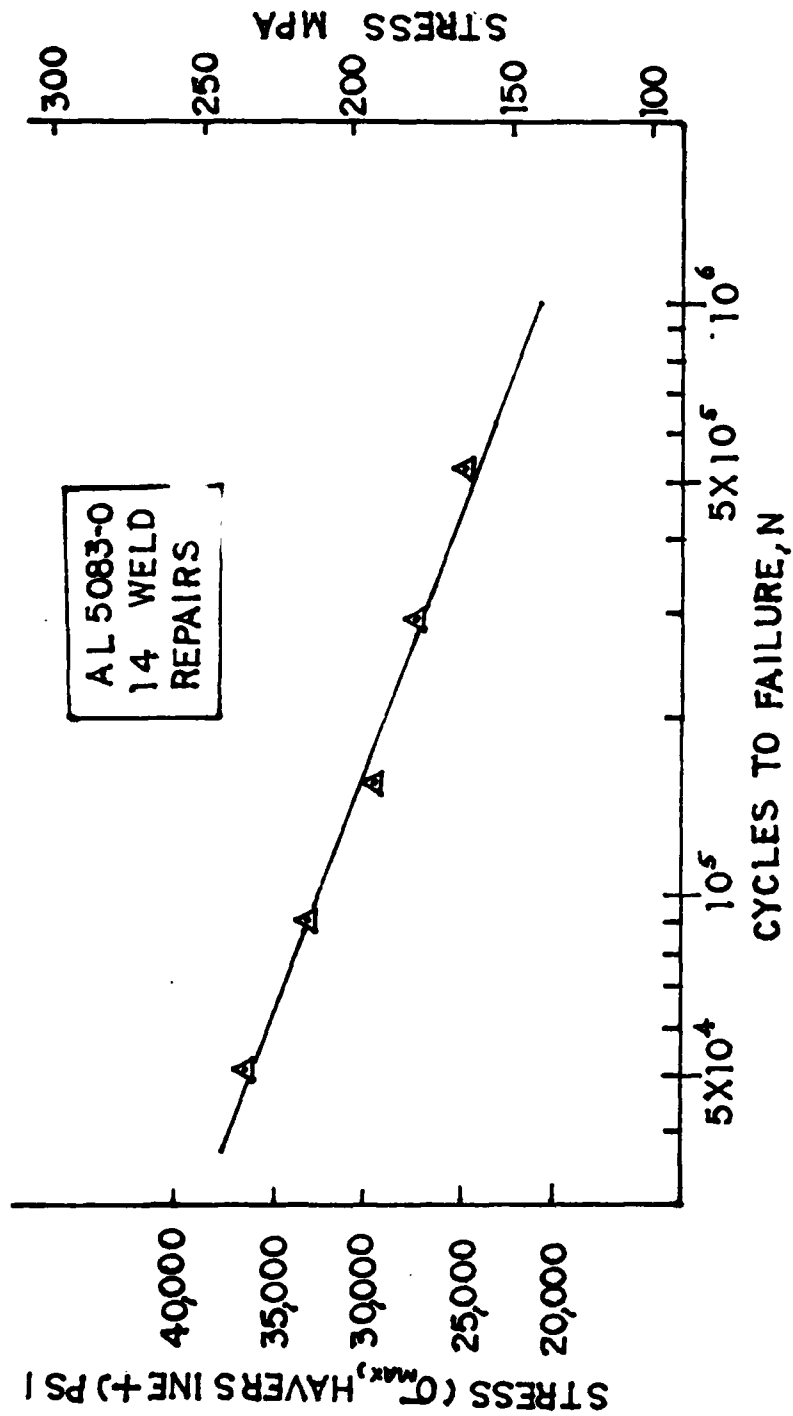
Figure 14. S-N Fatigue Diagram for AL 5083-0 which has been weld repaired fourteen times.  $\sigma_{max}$  on the haversine loading curve is plotted on the vertical axis while cycles to failure, N, is plotted on the horizontal axis.
